Reinforced concrete highway defects and damages in the roadway structures of bridges appearance to be analysis

Malikov G.

Tashkent State Transport University, Department of Bridges and tunnels, assistant

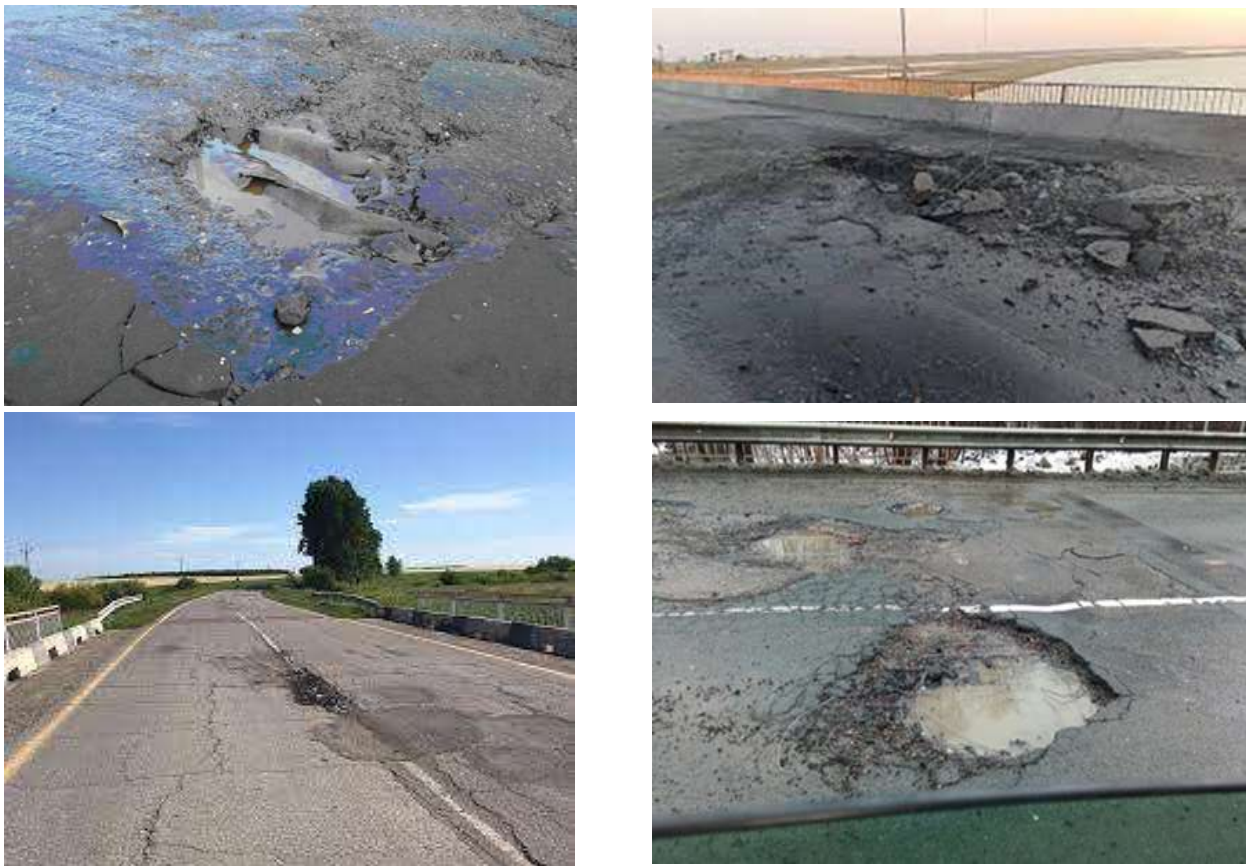
Studies on bridges show that the deterioration process of the roadway begins with the appearance of cracks in the asphalt concrete pavement. Over time, these cracks lead to the destruction of the asphalt concrete layer, which in turn leads to the failure of the protective layer and waterproofing system. At the same time, during the winter months, damage occurs due to the formation of ice as a result of water entering these cracks (Figure 1).

Figure 1. Different external effects as a result asphalt on the cover appearance to be defect and injuries

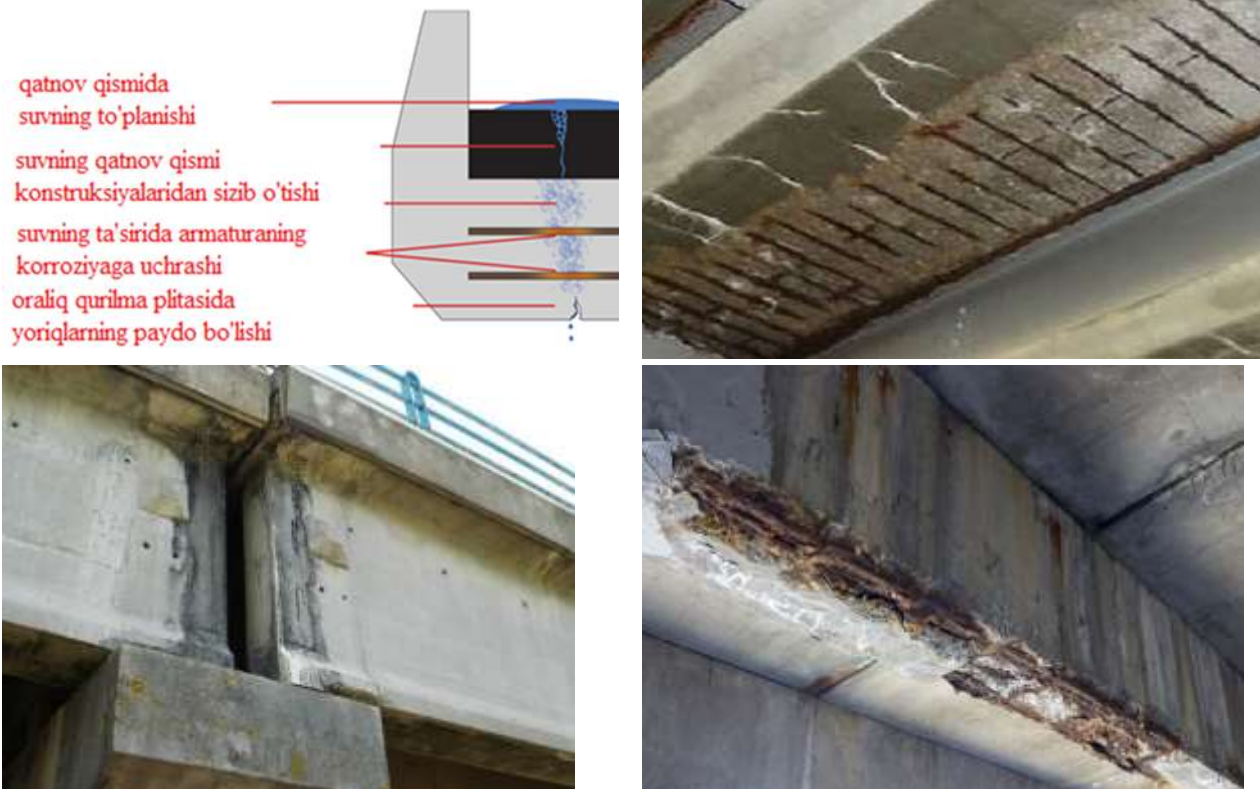
From *a technological* perspective, the main disadvantages are (*Figure 2*):

- Insufficient coverage: This occurs when the waterproofing material does not provide sufficient coverage over the entire surface of the bridge deck. Cracks allow water to penetrate, leading to the occurrence of a failure phenomenon (Figure 2);
- Improper application: If the waterproofing material is not applied correctly according to the manufacturer's instructions or industry standards, it can lead to defects. This can include incorrect thickness, inconsistent application, or insufficient drying time, which reduces the effectiveness of the waterproofing system;
- contractors are poorly qualified and not adequately equipped to use new technologies in bridge construction, or old methods are still used;

Figure 2. Defects caused by improper application of waterproofing.
